Study on Effect of Repair Welding Process on Clad Interface of Austenitic Stainless Steel and Structural Steel

Abstract

Keywords : *Welding; Austenitic Stainless Steel; Structural Steel; Cladding; Repair*

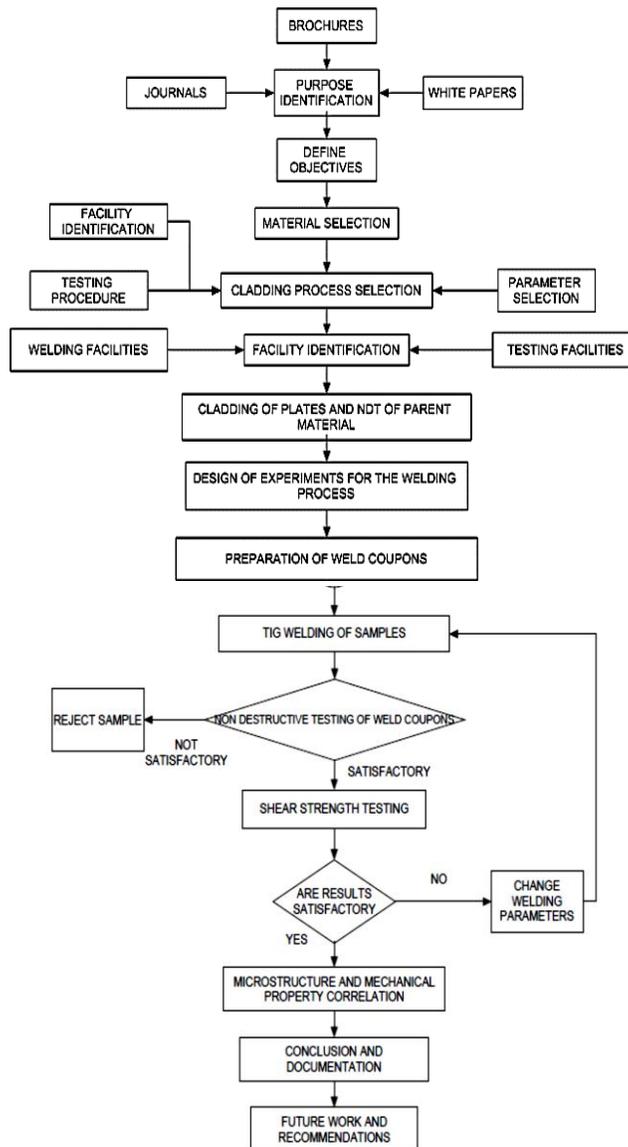
Fig. 1 Methodology

Based on the experimental objectives the following methodology is adopted to carry out this work. The methodology flow chart is shown in Fig. 1.

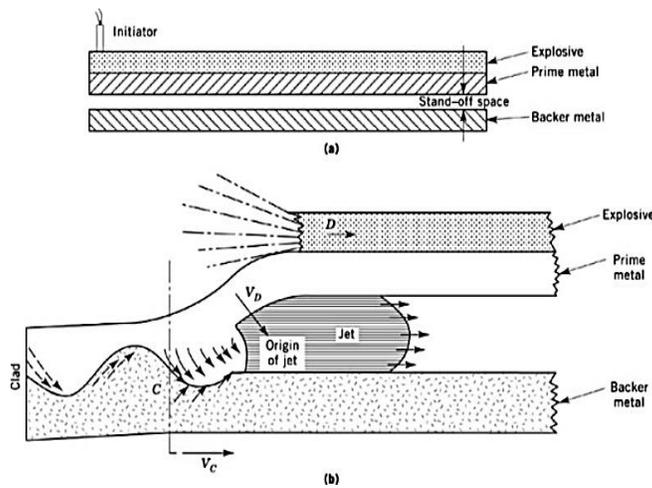
Fig. 2 Explosion cladding process [13]

Cladding is a process of joining two dissimilar materials in order to obtain combined properties for several demanding applications such as shipbuilding, pressure vessels, heat exchangers etc. Cladding of materials can be obtained through hot roll bonding, explosive cladding and weld overlay process. In this work, a clad combination of 316L austenitic stainless steel (3mm thick) and IS 2062 (12mm) structural steel is obtained by means of explosion cladding process. This type of clad combination of stainless steel and structural steel is used in applications requiring a combination of both strength and corrosion resistance. Explosion cladding or welding or bonding process is used because of its ability to clad a wide variety of material combination. It involves the formation of metallurgically bonded interface due to a controlled progressive detonation of the clad layer by means of explosives on to a backing substrate. The wavy interface formed between the two materials due to impact created from high velocities in the range of 250 to 500 m/s [12] is responsible for its high bond strength. Also, the removal of oxides present between the material interface produces a highly clean bond. The interface produced through this process is stronger enough to be used in applications requiring corrosive and structural properties and the failure usually takes place in the weaker of two metals rather than the bond interface. The schematic of explosion cladding process is shown in the Fig. 2 [13].

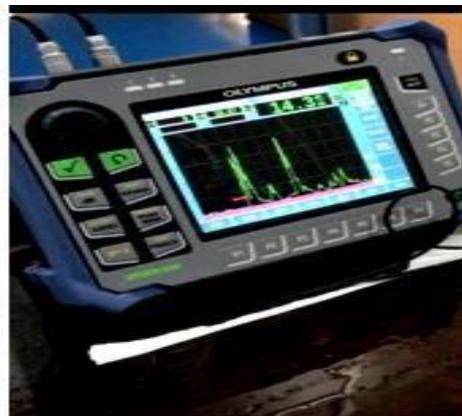
Fig. 4 Instance of backwall loss due to subsurface defect

3.The plate has a defect a distance of 75mm from the scanning side which is causing a complete loss of backwall. The defect is a line defect of length 13mm, the exact orientation of the defect has to be found by radiography testing only. The instance of backwall loss is shown in Fig. 4.

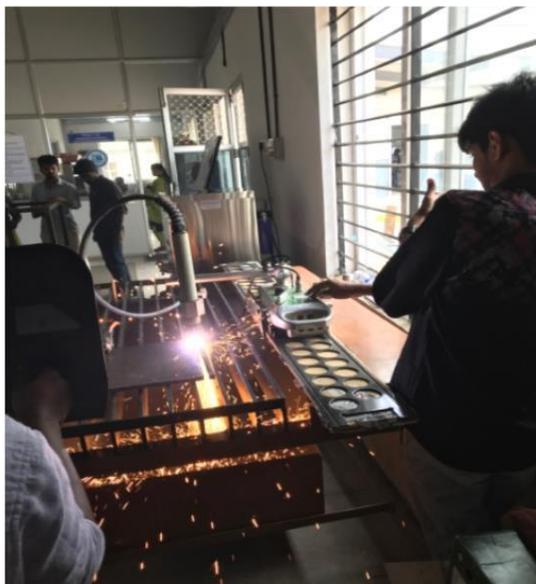
Fig. 5 Plasma cutting machine

The clad steel plates of dimension 310mm x 320mm each was procured for experimental purpose. To carry out welding and subsequent tests, weld coupons of dimension 90mm x 50mm were required. A cutting scheme was planned to incorporate the cutting losses and the plate was cut into small coupons using plasma cutting as shown in Fig. 5 with the parameter setting as shown in Table 3.

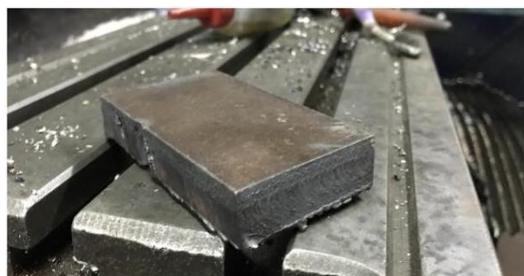
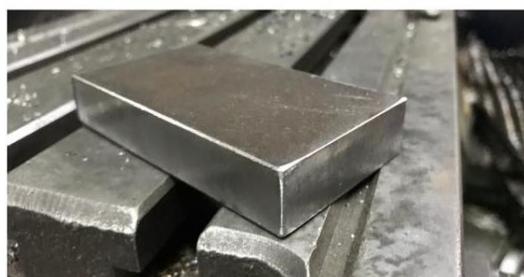
Fig. 6 Weld coupons before and after edge preparation

The cutting was started from the stainless-steel side because it was harder than the carbon steel. The cut plates had a slight taper because of improper plate clamping and the built-up edge on the carbon steel side was removed by subsequent machining as shown in Fig. 6.

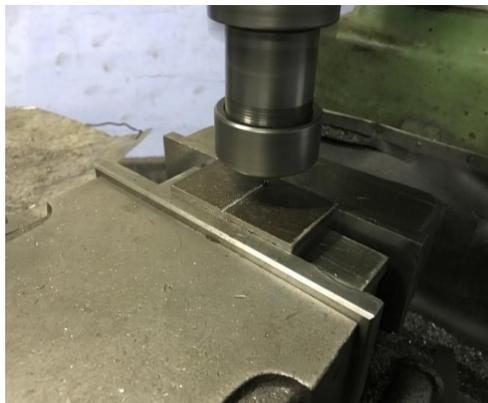
Fig. 7 Grooves machined using end mill cutter

Repair welding is usually carried out on the surface affected by corrosion. To understand the effects of repair process, grooves were machined on the stainless-steel side for different depths using end milling process. The specimen with groove preparation is shown in Fig.7.

The repair welding process was conducted by creating a groove of 50 mm x 3 mm (L x W) on the sample of dimension 90 mm x 50 mm x 15 mm. The groove depth is varied with different dimensions of 1 mm, 1.5 mm and 2 mm. Welding process was carried out with 309L filler material with a wire diameter of 0.8 mm. The parameters and their values are shown in Table 4.

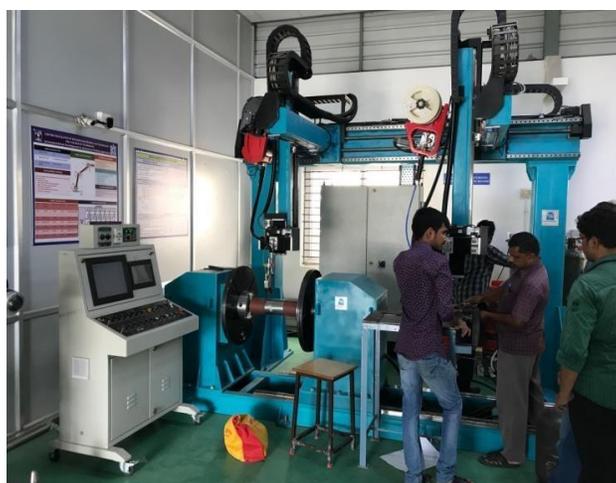
Fig. 8 Gantry type welding machine

A Gantry type automated Tungsten Inert Gas Welding was used to repair the coupons as shown in Fig. 8. The plates were clamped using C clamp and aligned perfectly to the direction of nozzle movement. The

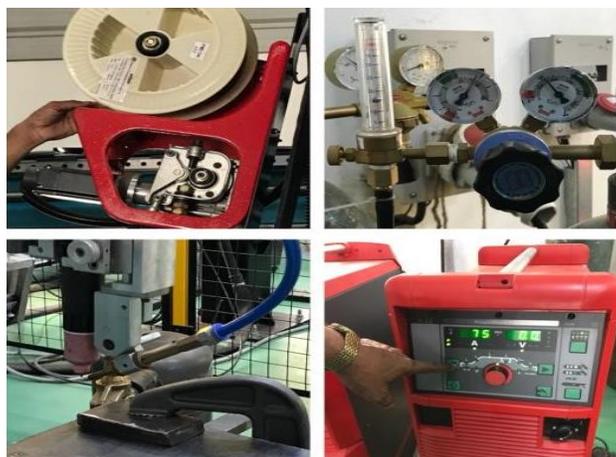
Fig.9 Experimental setup for welding

welding parameters are shown in Table 5 and the welding setup, camera vision and welded specimen are shown in Fig. 9, 10 and 11 respectively.

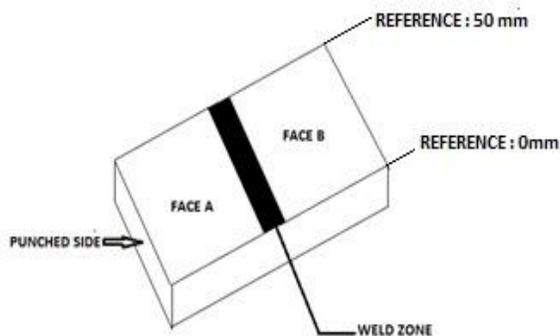
Fig. 12 Face representation for ultrasonic testing

Representation of the reference faces A and B for ultrasonic testing are indicated in Fig. 12 and faces C and D represents the exact opposite side of faces A and B respectively.

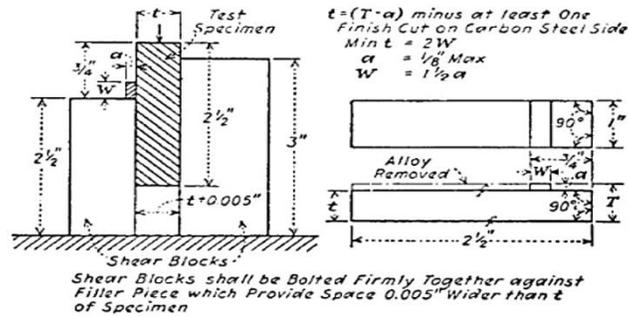
Fig. 13 Shear test specimen in accordance with ASTM A264 [14]

This is a type of destructive testing where the load is applied on the material parallel to the bond interface and the failure occurs along the interface direction. Shear test was carried out as per ASTM A264 standard to determine the tensile shear strength of the clad plate material [15]. In this testing, sample dimensions of 64.5mm x 25.4mm x 15mm were used with the clad metal width being 4.5mm. As per standard the criterion for evaluation is that the minimum required shear strength of the clad plate should be 140 MPa. The specimen dimension and the loading setup are shown in Fig. 13 [14].

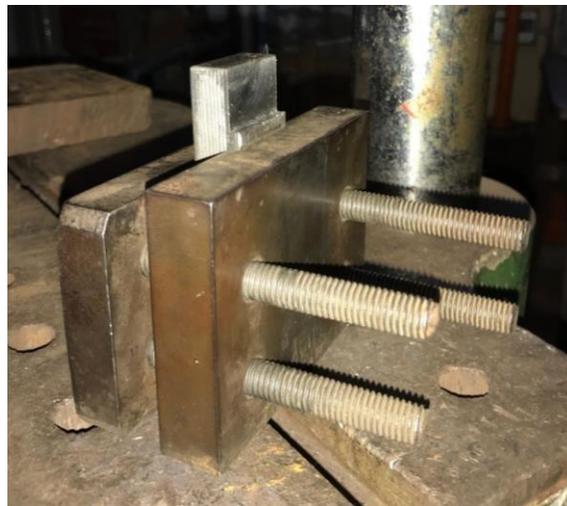
Fig. 14 Setup for Shear testing

A fixture is designed and fabricated to carry out the shear tests of the clad specimen as per ASTM A264 standards. The fixture setup used for testing is shown in Fig. 14.

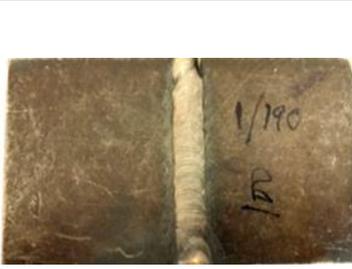
<ol style="list-style-type: none"> Under fill 15 - 17 mm at Face A Point defect at 21 mm SWLOF 27 - 30 mm and 35 - 40 mm at Face A 	Visual rejection
A6

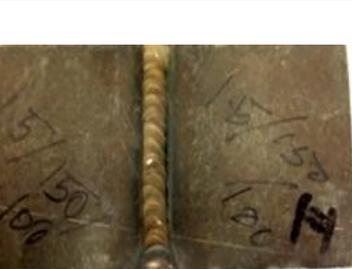
<ol style="list-style-type: none"> SWLOF from 19 - 24 mm at Face B Under fill from 5 - 40 mm at Face B 	Visual rejection
B2

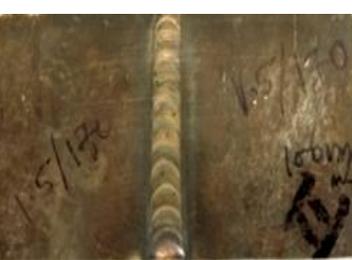
<p>90° Probe:</p> <ol style="list-style-type: none"> Back wall shift up to 14.45 mm for entire weld length <p>45° Probe:</p> <ol style="list-style-type: none"> All indication below 40% FSH (recordable but not significant) 	Accepted
B3

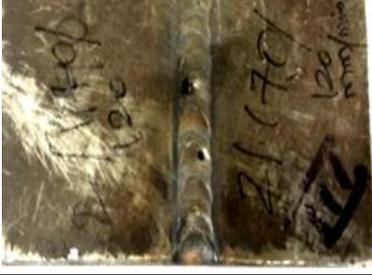
C3

90° Probe: 1. Back wall shift 12.8 mm from 0 - 5 mm and 23 mm at Face B 45° Probe: 1. Pointed indication (non recordable) at 20 mm	Accepted

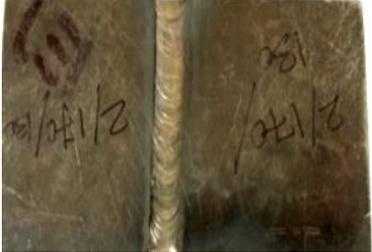
<p>1. Blow hole at 18 mm and 30 mm 2. Under fill from 15 - 20 mm at Face B</p>	Visual rejection
C4

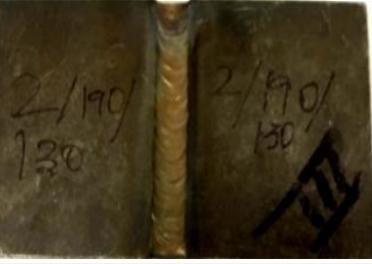
<p>90° Probe: 1. Back wall shift of 13.46 - 13.6 mm from 25 - 49 mm 45° Probe: 1. Internal defect (continuous) from 8 to 18 mm @ Face D</p>	Accepted
C5

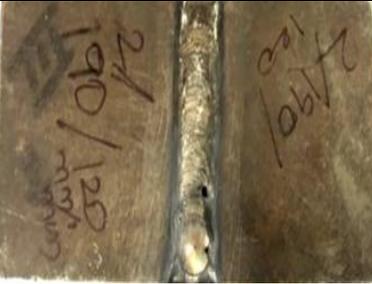
<p>90° Probe: 1. No significant defect 45° Probe: 1. Internal defect location at 34 mm (non recordable)</p>	Accepted
C6

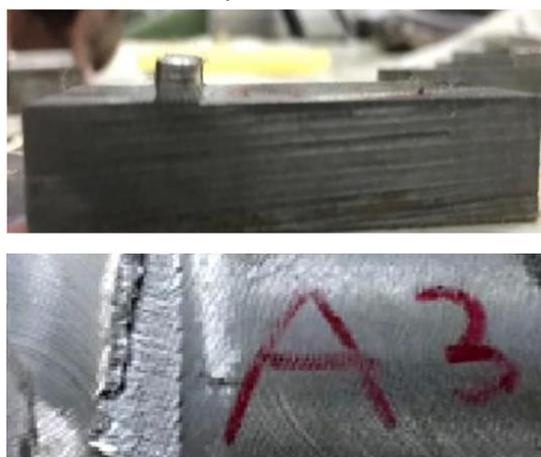
Fig. 16 Specimen before and after testing

Testing was carried out on nine samples which satisfied the required criteria from ultrasonic testing. These shear strength values were used in comparison to study the effect of repair welding on the clad interface. The test specimen used is shown in Fig. 15. The results obtained from the test are shown in Table 10. It was observed from the table that specimen A2 has the maximum shear load of 70.8 kN.

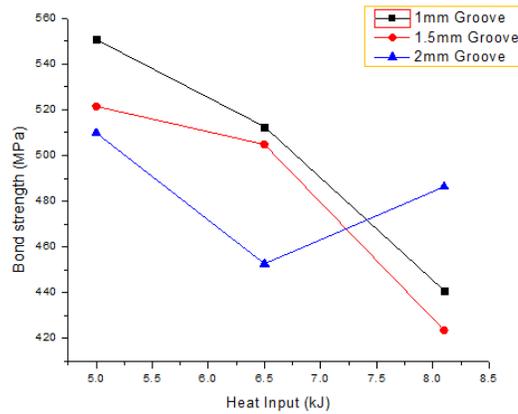
Fig. 16 Heat input vs Bond strength Relationship

The shear test results were plotted to determine the effect of welding heat input on the interface bond strength for a repair groove depth. The results are shown in Fig. 16.

The plot clearly shows that the increase in value of heat input results in decrease in the interface bond shear strength. The primary reason for the drop in interface shear strength is that as the heat input increases the effect of welding reaches the interface i.e. remelting of the clad interface takes place resulting in the formation of coarse grains at the wavy interface. As the grains get coarse, propagation of cracks in easier thus causing earlier failure in the product [18]. The progressive coarsening of the interface grains is shown in Fig. 17.

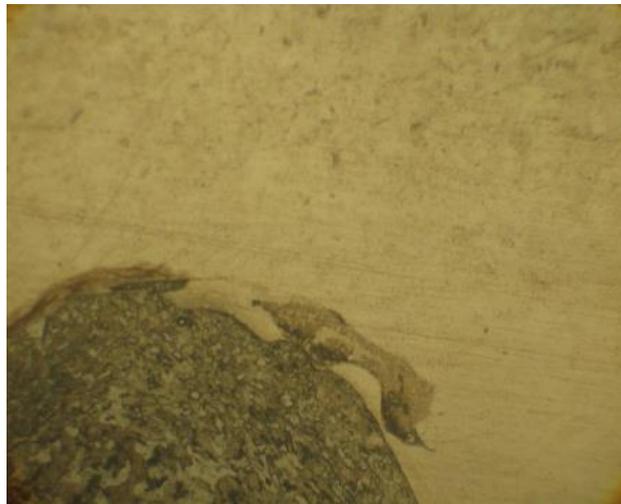
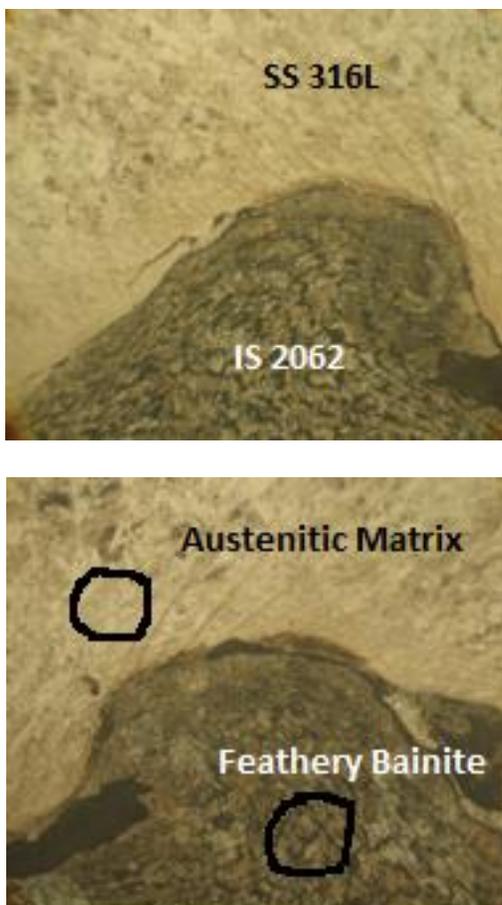
Fig. 17 Progressive coarsening of clad interface

The Fig. 17 also clearly shows the metallurgical aspects of the material. The stainless steel is austenitic based while the low carbon steel is characterized by formation of feathery bainite on the ferrite matrix.

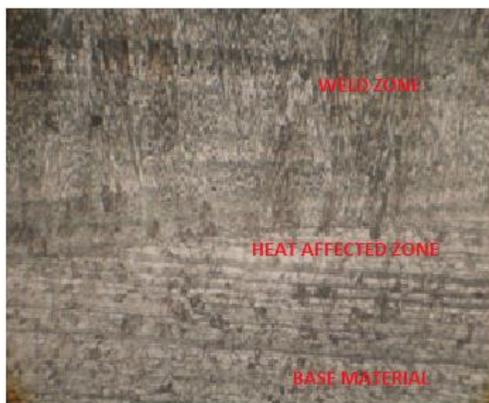
Fig. 18 Various Zones at Weld interface

The weld interface is shown in Fig. 18. The weld zone is clearly distinguished from the parent material by the dendritic structures, followed by the coarse grained heat affected zone and unaffected parent material with grains.

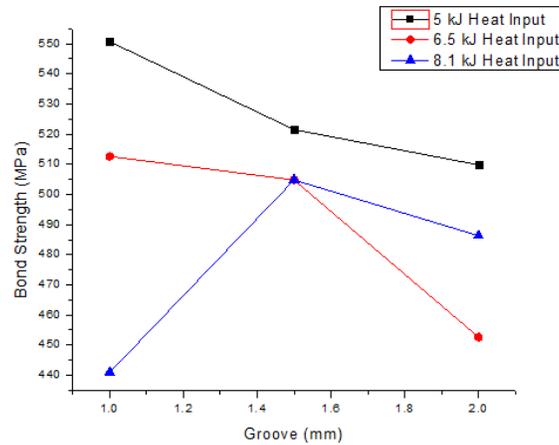
Fig. 19 Groove depth vs Bond strength Relationship

The shear test results were plotted to determine the effect of repair groove depth on for a provided heat input on interface bond shear strength. The results are shown in Fig. 19.

The above plot clearly shows a drop in bond strength as the groove depth increases for a fixed heat input. It can be seen that as the depth of groove increases, the base of groove comes in close proximity with the clad interface. Thus a small heat input provided results in remelting and coarsening of grain structure at the clad interface [19] [20]. The microstructural images supporting the above claim are shown in Fig. 20.
